An Analysis of Magnesium Oxide Wall Panels Located in an Educational Building in Trinidad — A Case Study

Frank Byron
Nazim Mohamed

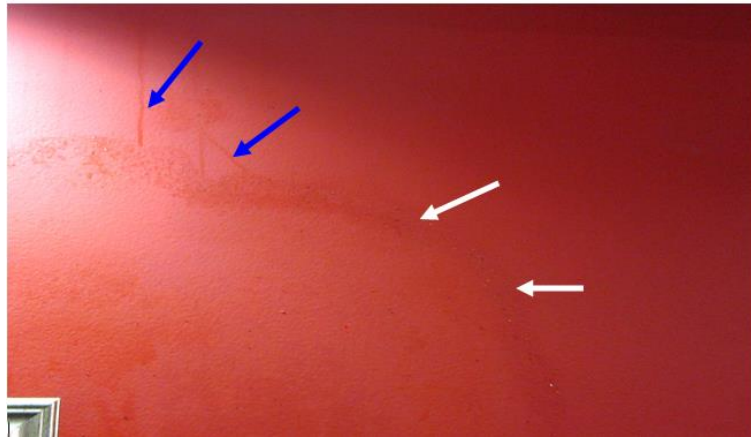
Fig. 1. The walls were painted red and displayed darker and lighter tints of colour at certain areas; the darker areas also showed liquid stains (white arrows) and small droplet formation of liquid percolated on the wall (blue arrows)

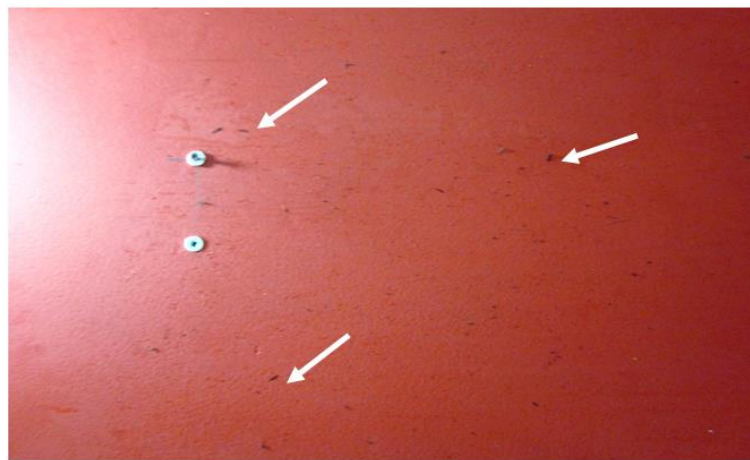
Fig. 2. In the darker tinted region of the wall that was covered by picture frames, dead insects were seen stuck to the damp regions (white arrows)

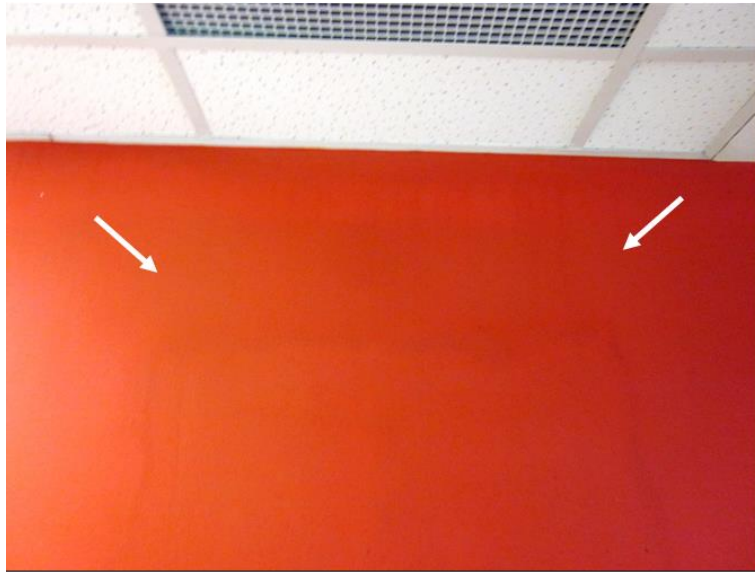
Fig. 3. The darker tinted damp region was observed to be in close proximity to the supported steel frames where the wall panels were cladded (white arrows)

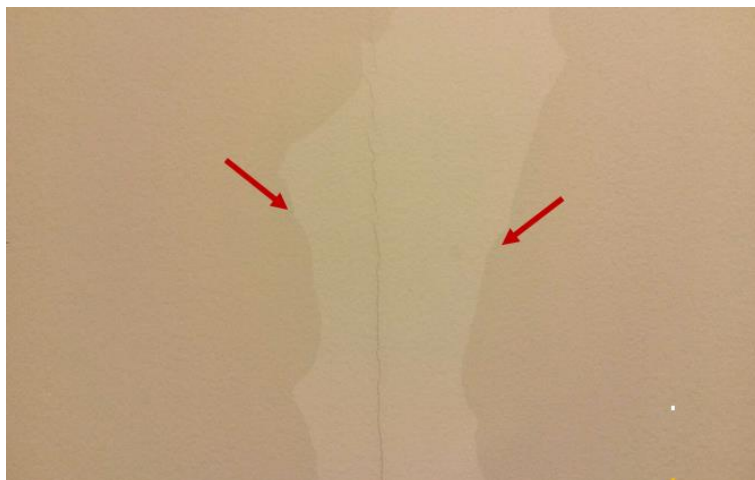
Fig. 4. The walls were painted in a cream colour and displayed similar darker and lighter tints at certain areas; the darker areas also showed liquid stains (red arrows)

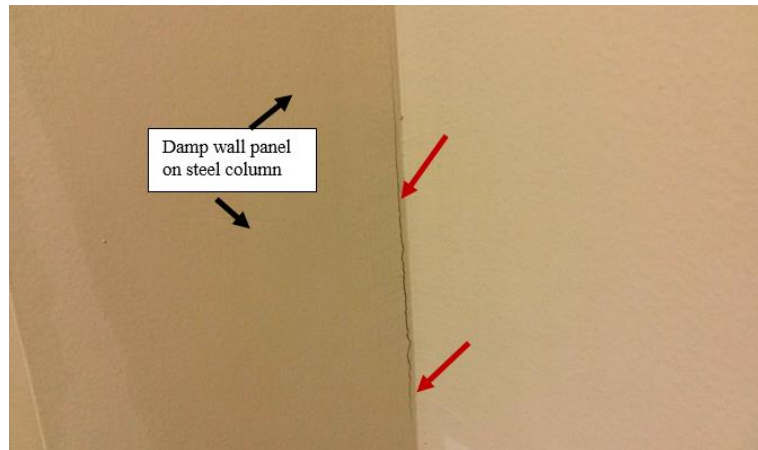
Fig. 5. A darker tinted damp region was observed to be in close proximity to the main steel column. Crack propagation occurred along the length of the column wall at the corner to the adjacent wall (red arrows)

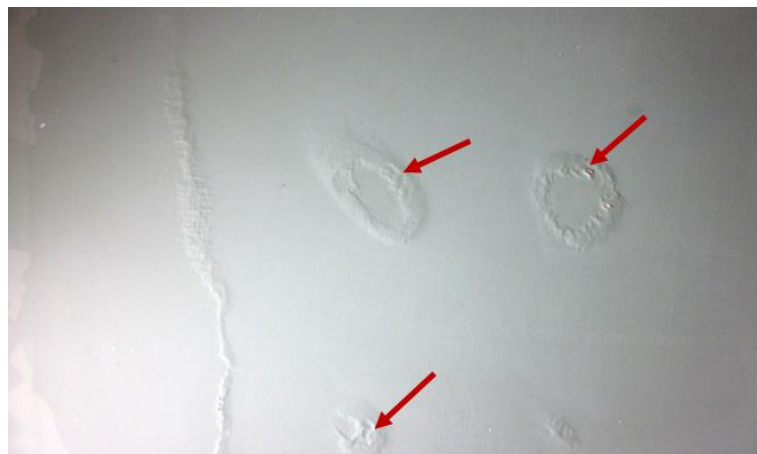
Fig. 6. The walls were painted in a grey colour and displayed a larger section of the darker tint at certain areas. Severe blisters occurred on the painted wall (red arrows)

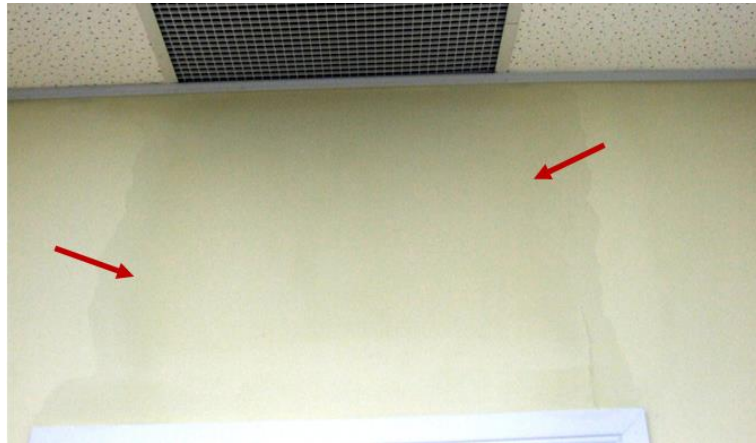
Fig. 7. The darker tinted damp regions were also observed to be in close proximity to the supported steel frames where the wall panels were cladded (red arrows)

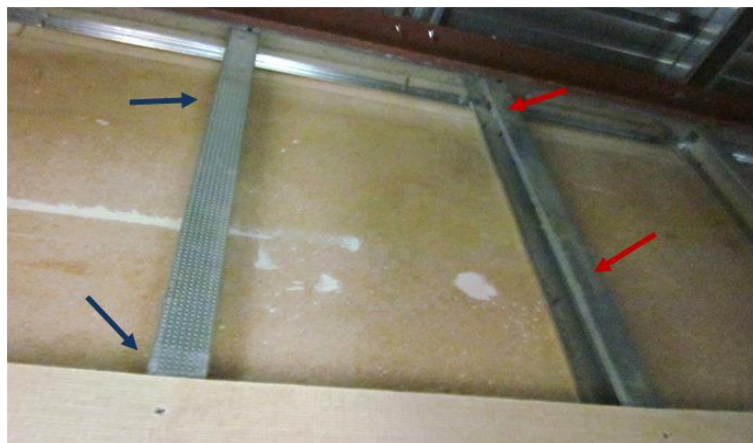
Fig. 8. The ceiling close to the affected wall was removed; it was observed that the galvanized steel showed localized white spots (red arrows) and the cladded inner panel also showed a darker tint in close proximity to the metal frame (blue arrows)

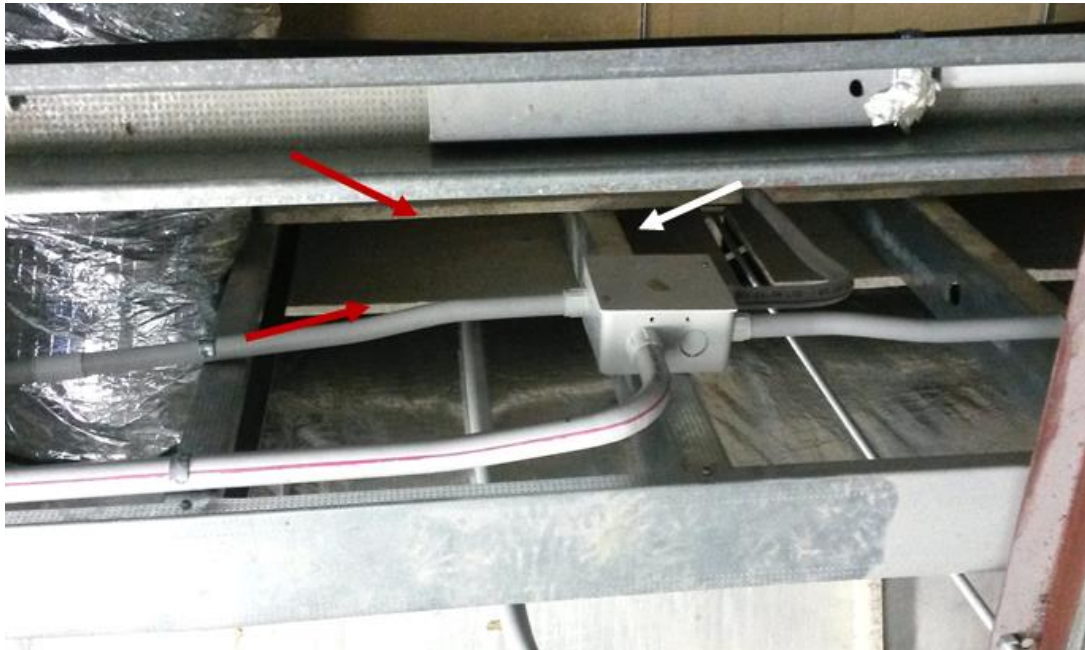
Fig. 9. The wall panels extended in the Attic (red arrows) and were left opened to the attic's environment. The electrical conduit passing through the hollow opening of the wall panel (white arrow) can be seen

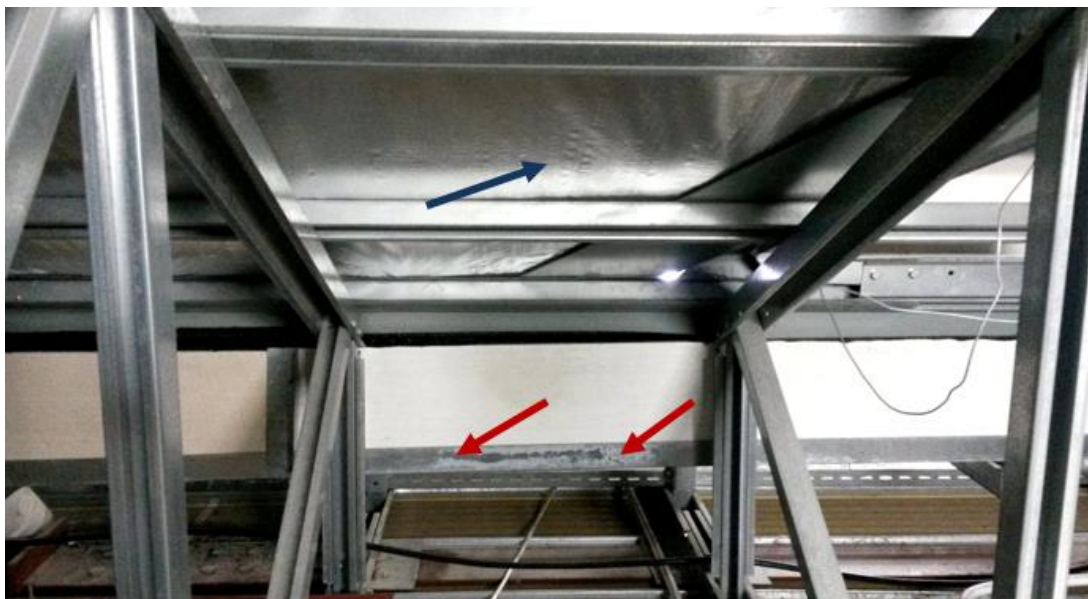
Fig. 10. Localized white rust (corrosion) was observed on the galvanized steel bar channels (red arrows) and the insulation attached to the underside of the roof (blue arrows)

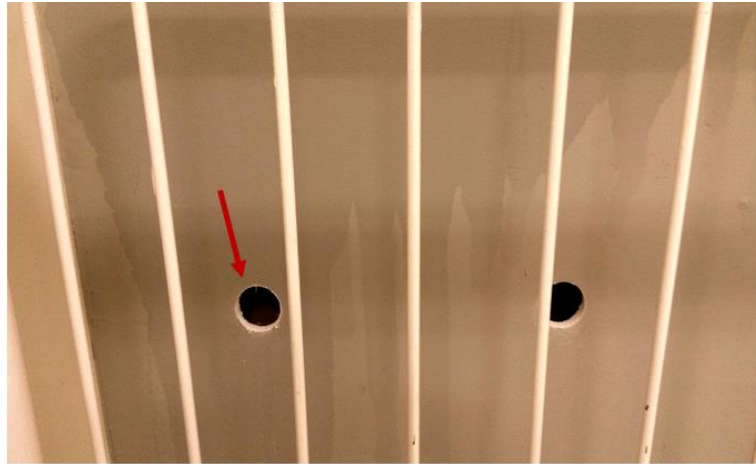
Fig. 11. A typical picture is shown of where the core samples were taken. Note the darker region within the liquid stains (red arrows)

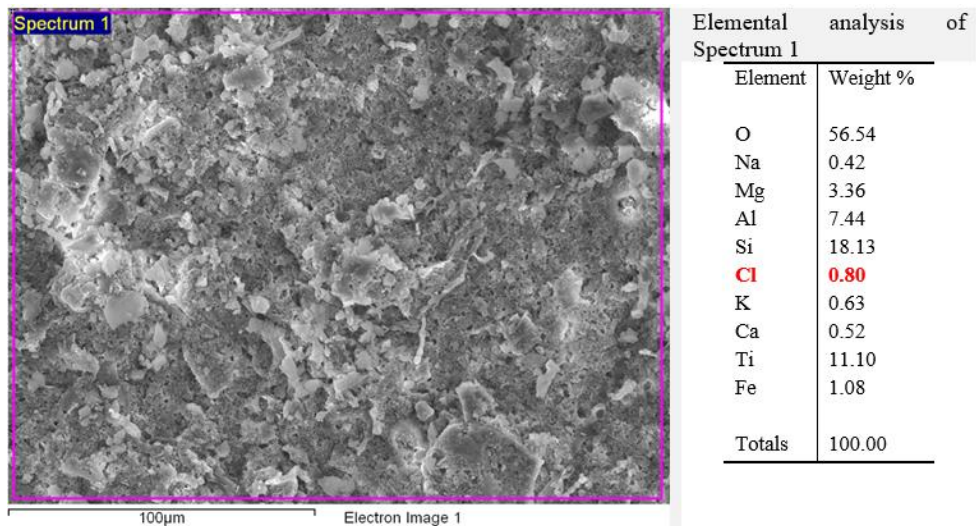
Fig. 15. SEM micrograph of lighter region of painted board showed the chlorine element had a low percentage concentration at the surface

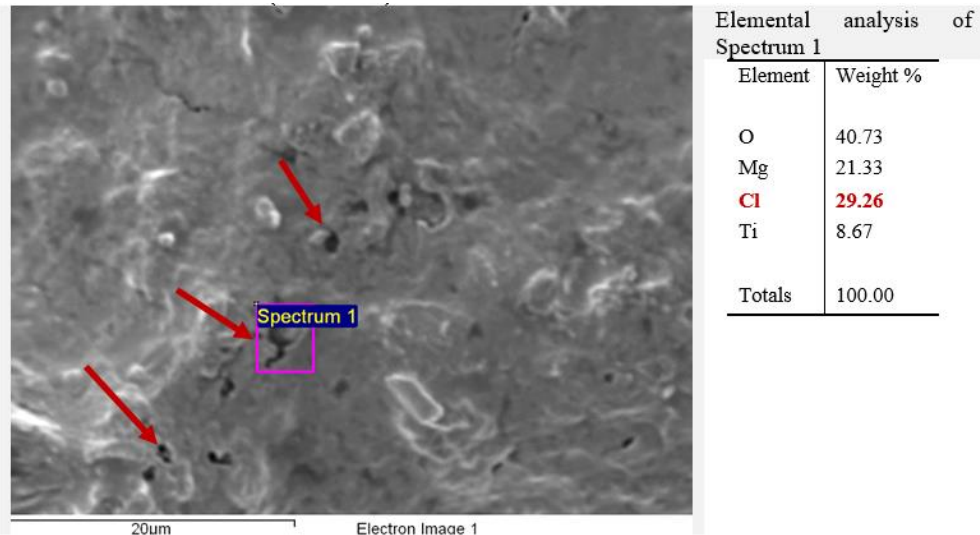
Fig 16. SEM Microprobe at a higher magnification of the painted surface in the darker region showed small pores, and high concentration of chlorine (red arrows)
